STATE OF CALIFORNIA
DEPARTMENT OF WATER RESOURCES
DIVISION OF RESOURCES PLANNING

BULLETIN NO. 81

INTRUSION OF SALT WATER
INTO GROUND WATER BASINS OF
SOUTHERN ALAMEDA COUNTY

December 1960

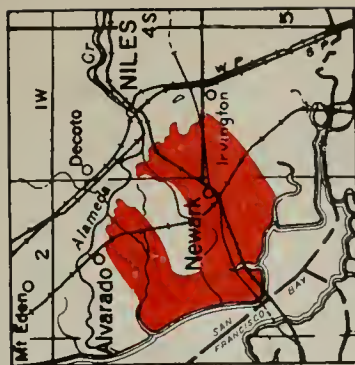
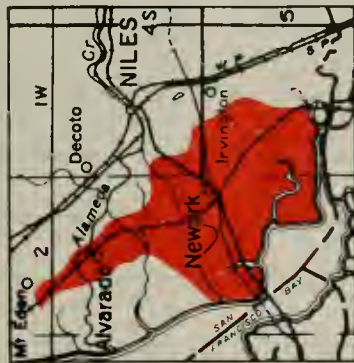
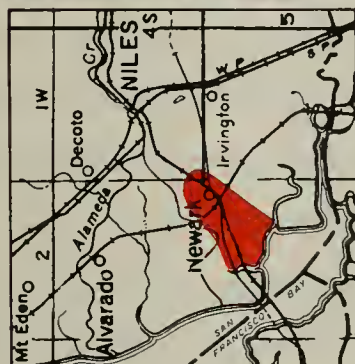
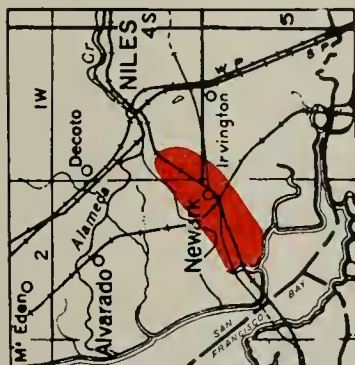
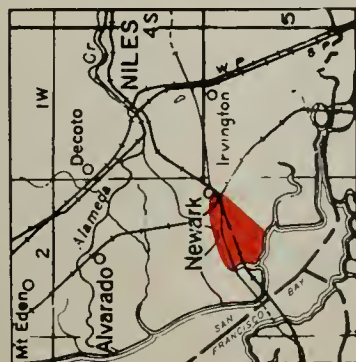
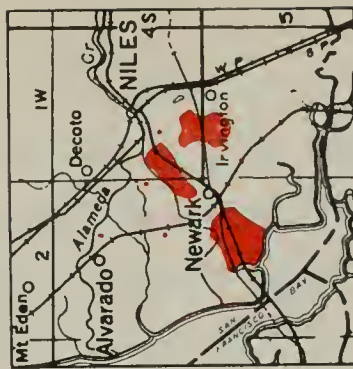
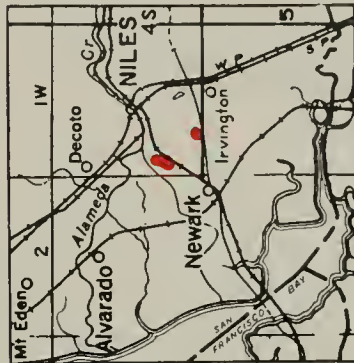
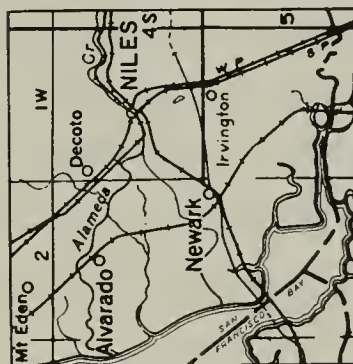
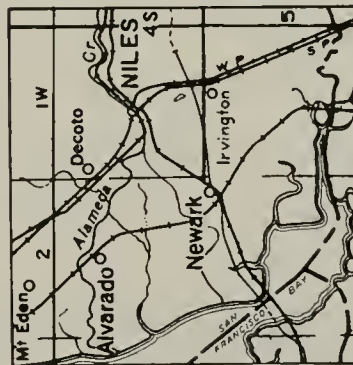
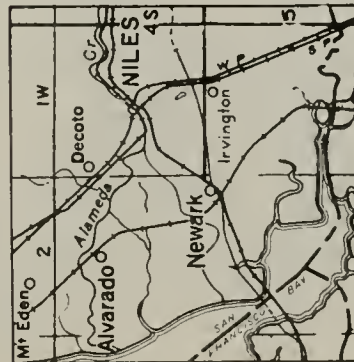
DEGRADATION OF SHALLOW (NEWARK AQUIFER) AND DEEP (CENTERVILLE AQUIFER) GROUND WATER

During the six-year period from 1936 to 1942, there was a moderate improvement in the quality of water from shallow wells, probably due to effects of above normal rainfall. In 1950, and again in 1957, however, it was found that bay water had intruded further inland in the Niles cone area. The progressive degradation of waters in the Newark aquifer is illustrated on Figure 1.

deep wells in the vicinity of Newark and Alvarado were reported to be yielding salt water. By the end of 1950, about 100 acres of the Centerville aquifer produced water with chloride concentrations in excess of 350 ppm; this area of degraded water increased to about 230 acres early in 1951.

Information collected by the Department of Water Resources during a county-wide water resources investigation indicated that 660 acres of the Centerville aquifer were degraded by salt-water intrusion during the winter of 1953-54 (27). A few years later, in 1956, a reconnaissance survey indicated an alarming increase in the area affected (19).

By late 1958, about 2,630 acres of the Centerville aquifer were affected (Plate 6). Samples collected during 1959 show that about 3,000 acres were degraded by salt water.

The foregoing observations, summarized on Figure 1, clearly show a progressive increase in the area of degraded water in the Centerville aquifer.

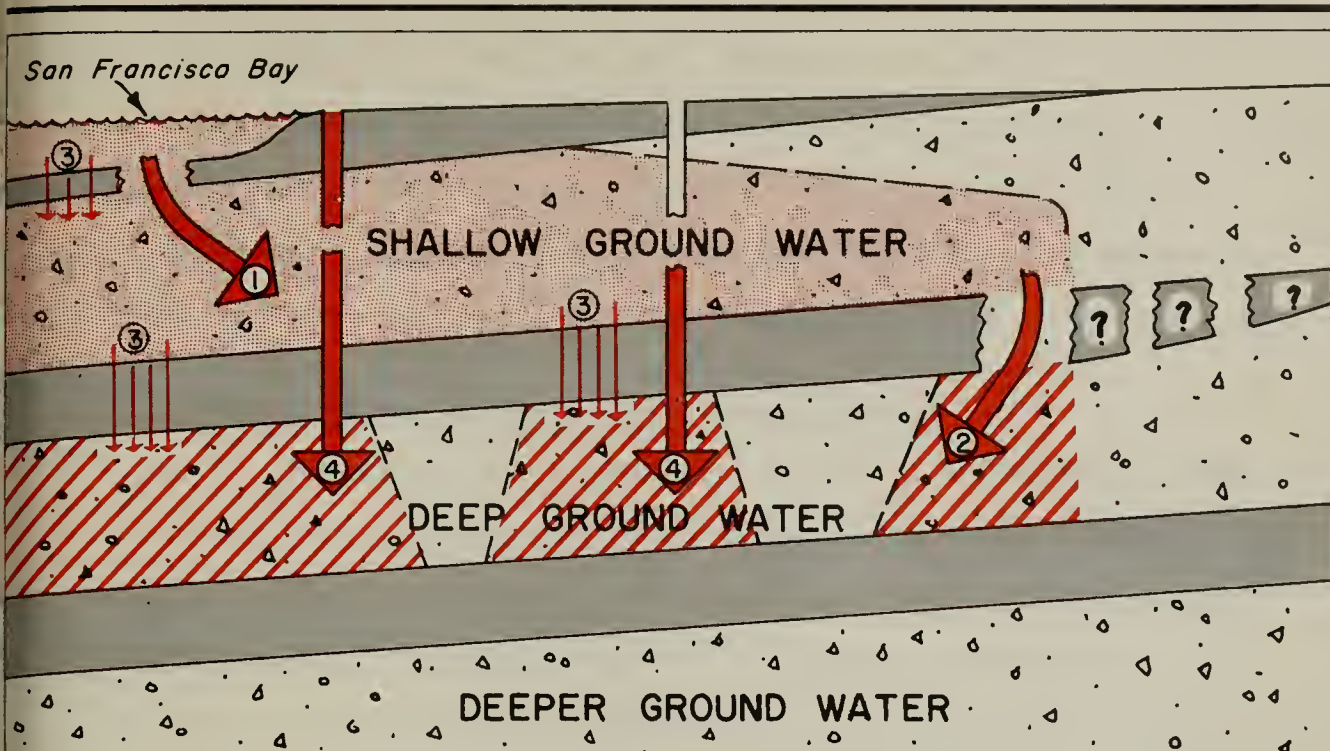
Possible means for entry of salt water into ground waters are delineated on Figure 2. It is seen that there are three natural routes for subsurface movement of salt water into ground-water reservoirs. The one man-made route permits leaking or cascading of saline surface or ground water through wells. The shallow ground-water reservoir corresponds to the Newark aquifer and the deeper reservoirs correspond to the Centerville and Fremont aquifers.

The most probable point of entry of saline bay water into the Newark aquifer is beneath the deepest part of the tidal channel through Dumbarton Straits. Typically, bay muds and blue clay with a total thickness of about 50 feet overlies the Newark aquifer. Meandering tidal currents have eroded this material to a thickness of about 5 feet forming a "window" which extends over a width of about 2,500 feet for an undetermined distance. It is almost certain that, during maximum tidal currents, the bottom scour extends through the mud and exposes the gravels of the aquifer.

Some salt water may have entered the Newark aquifer through breaches in the clay layer underlying the tidal flats. At one time, springs existed along the western edge of Coyote Hills. Those channels through which spring water formerly flowed upward may now carry salt water downward. Pier and piling holes and abandoned water wells may also form breaches. The quantities of flow involved are relatively minor.

1. Direct movement of bay waters through natural "windows".
2. Spilling of degraded ground waters.
3. Slow percolation of salt water through reservoir roof.
4. Spilling or cascading of saline surface waters or degraded ground water through wells.

1. Spilling of degraded ground waters over the inland edge of the clay layer separating the Newark and Centerville aquifers.
2. Percolation of degraded ground waters through the clay layer separating the Newark and Centerville aquifers.
3. Leaking or cascading of saline surface or degraded ground waters through wells.

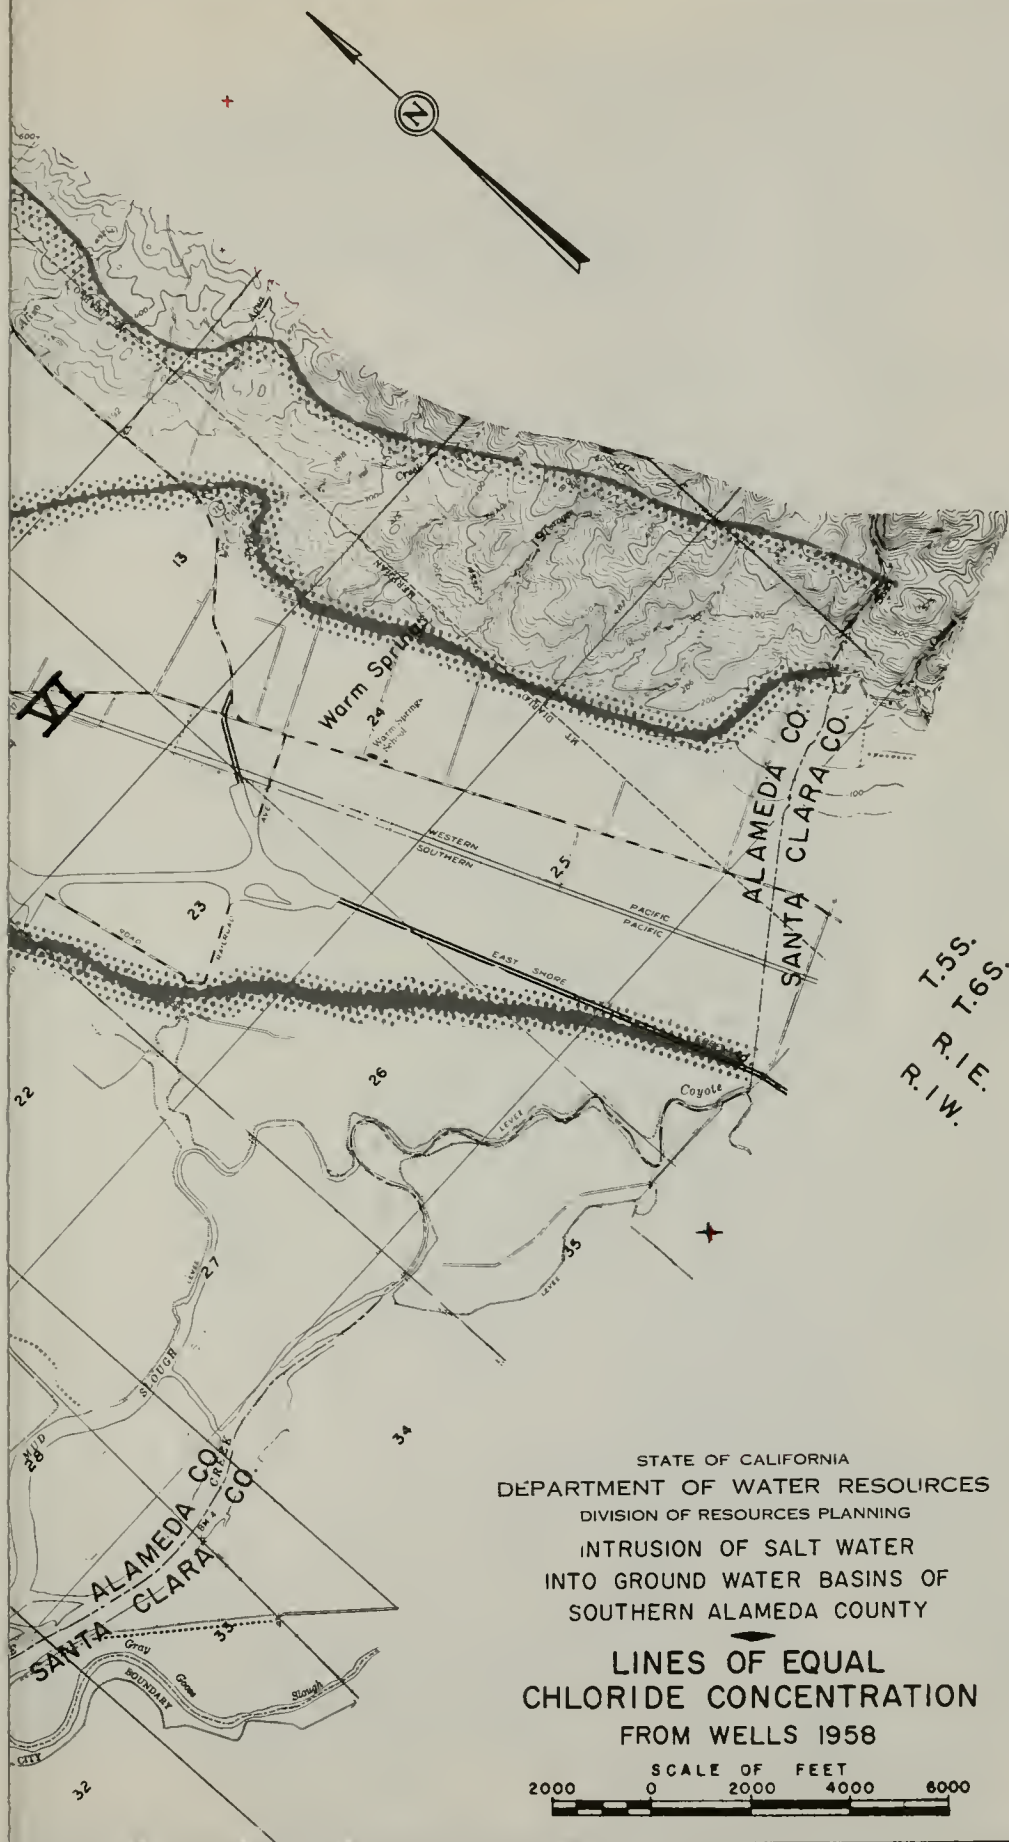
STATE OF CALIFORNIA
 DEPARTMENT OF WATER RESOURCES
 DIVISION OF RESOURCES PLANNING
 INTRUSION OF SALT WATER
 INTO GROUND WATER BASINS OF
 SOUTHERN ALAMEDA COUNTY
**LINE OF EQUAL
 CHLORIDE CONCENTRATION**
 FROM WELLS 1958

Plate 6 shows an isolated area in the vicinity of Alvarado and Newark where water of the Fremont aquifer was found to be degraded in 1959. It is important to note that degradation of this aquifer has begun.

Spill Over Inland Edge of Confining Clay Layer. The area affected by salt-water intrusion in the Centerville aquifer, as shown on Plate 6, extends inland to the vicinity of Fremont Boulevard. If this degradation were caused by spill of saline waters from the Newark aquifer over the inland edge of the separating clay layer, it could be postulated that the clay layer should end in this vicinity. To test this hypothesis, an investigation was conducted to determine whether the clay layer was present in this area.
